### **Wooded Areas Can Be Served by Northpoint Signals**

## V. Conclusions

### **Thirty Sites Tested, None Experienced DBS Signal Failure**

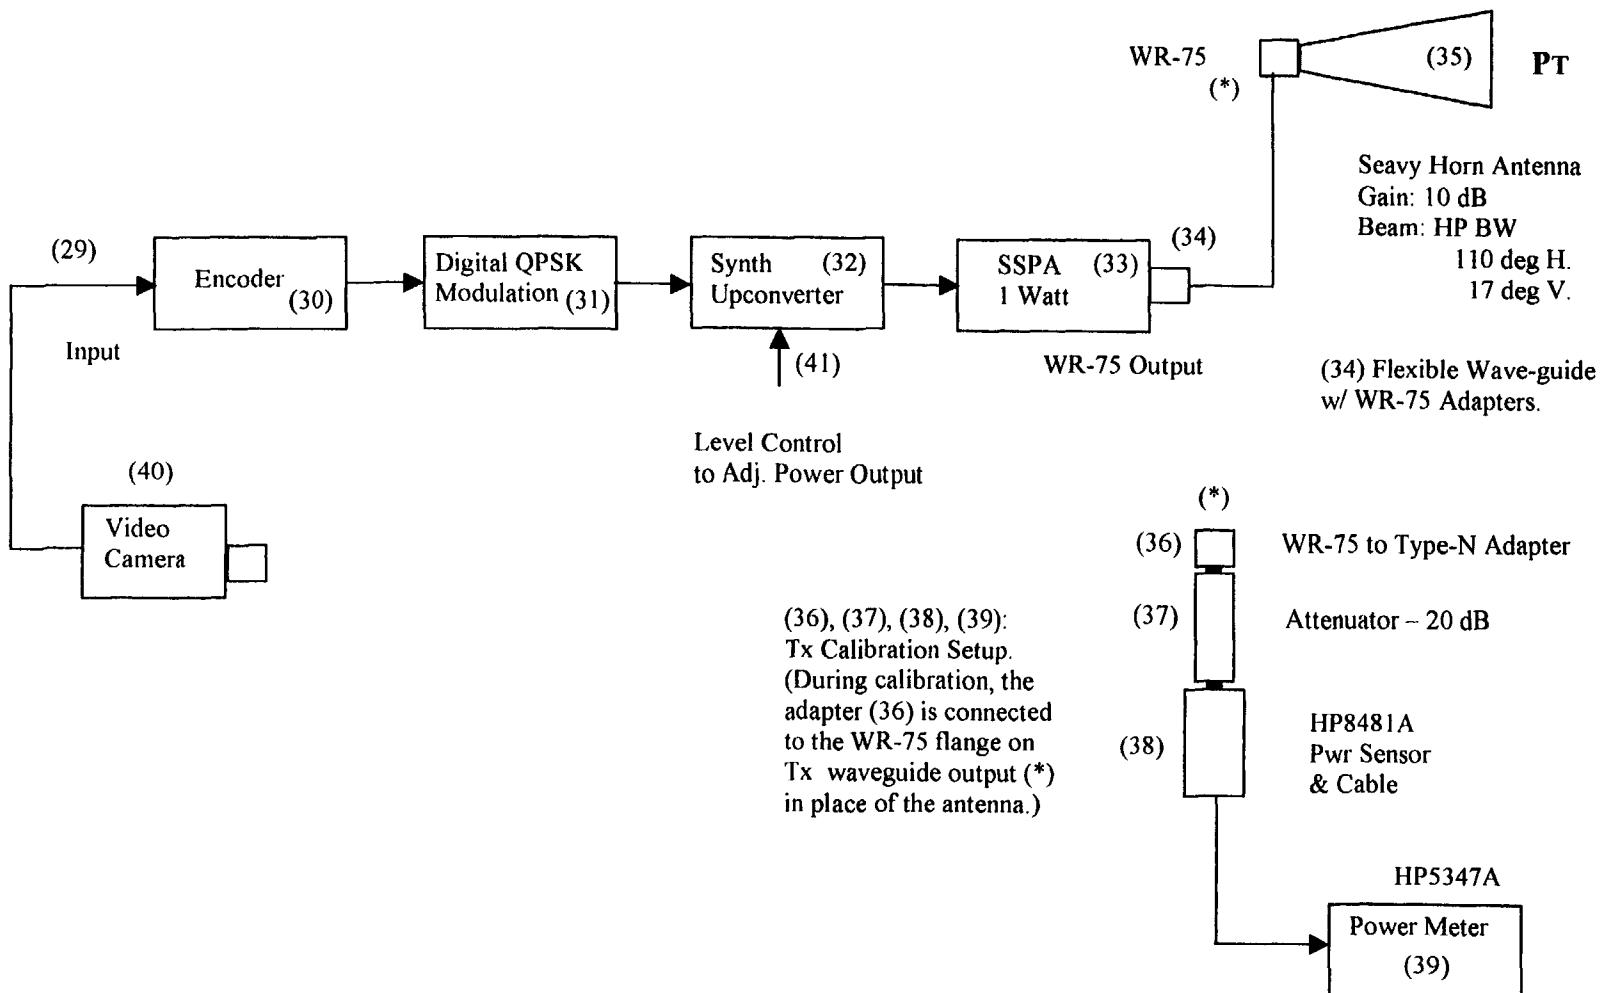
**Fig. III-1: Northpoint Terrestrial Transmitter Block Diagram.**

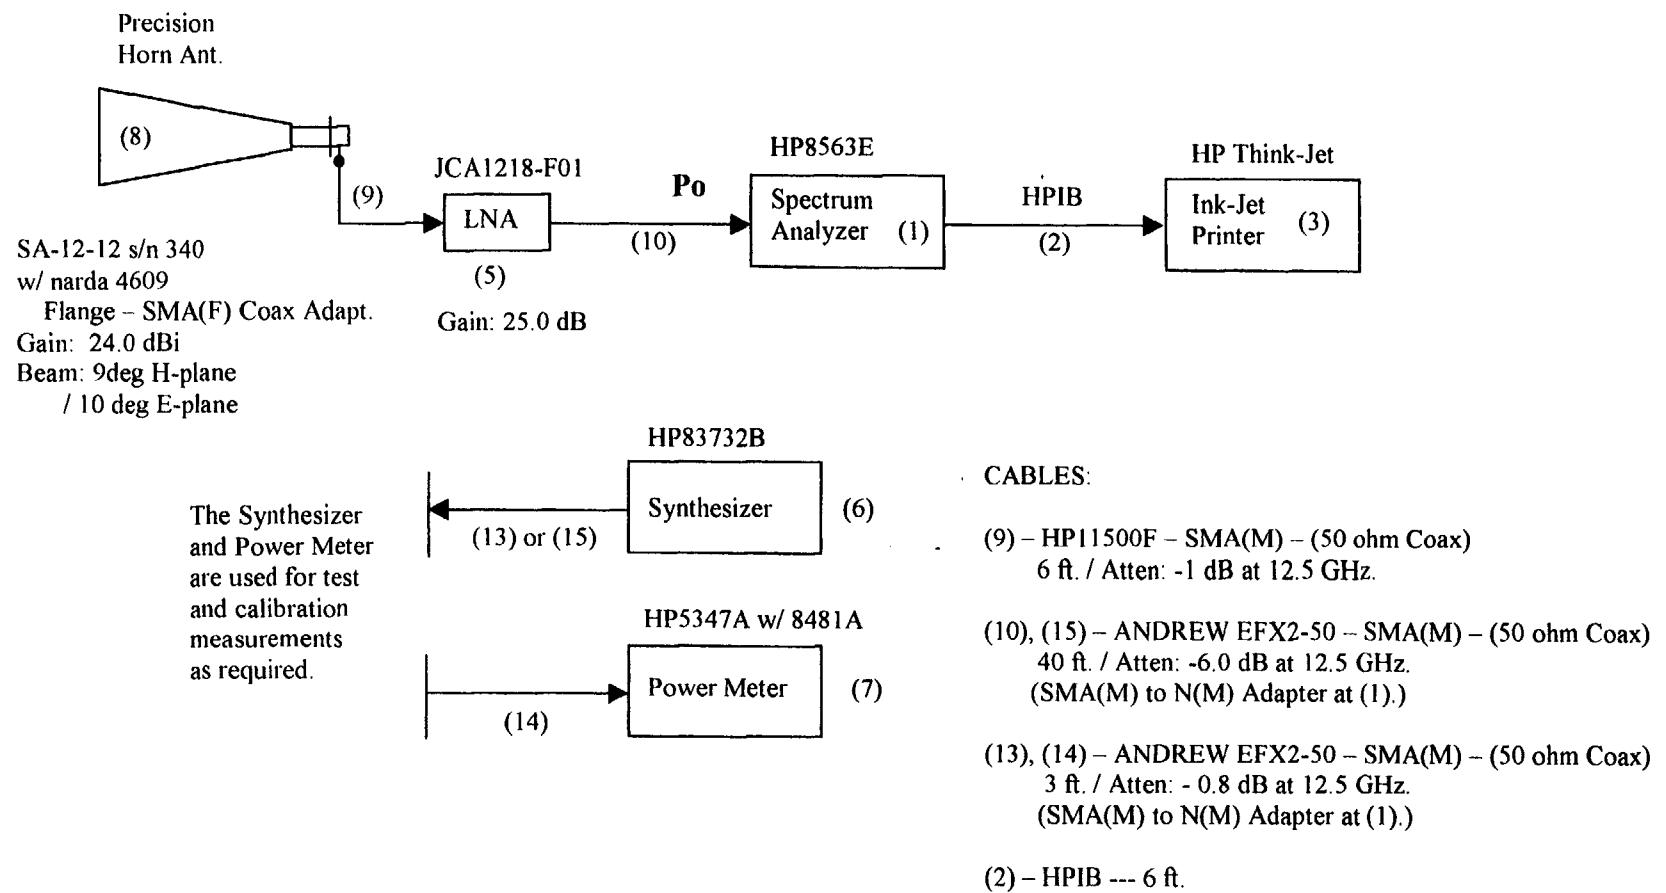
**Fig. III-2: Test Set System Block Diagram.**

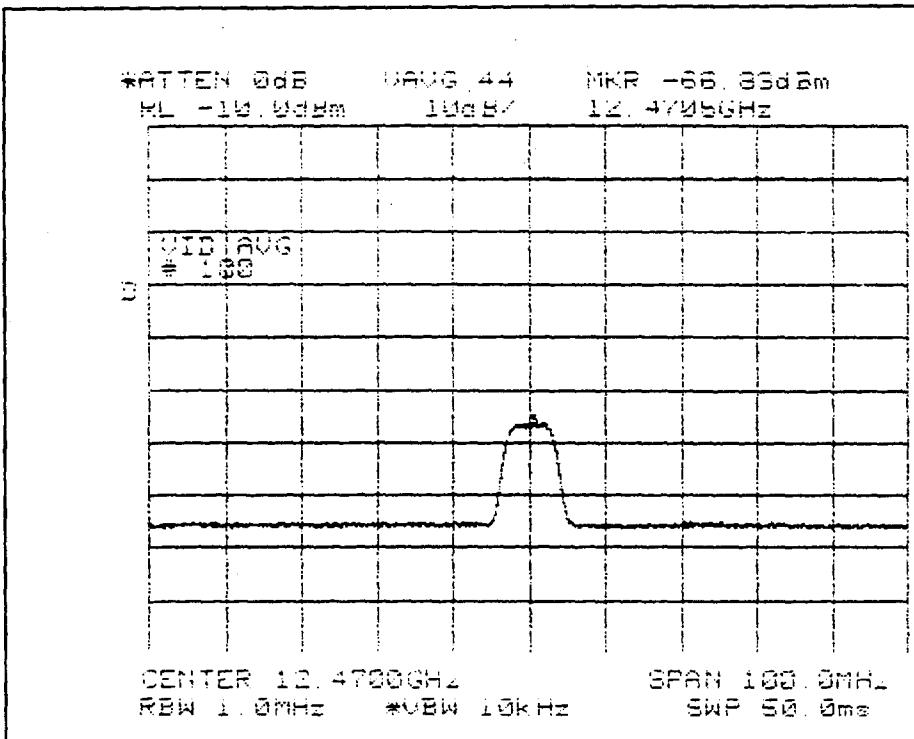
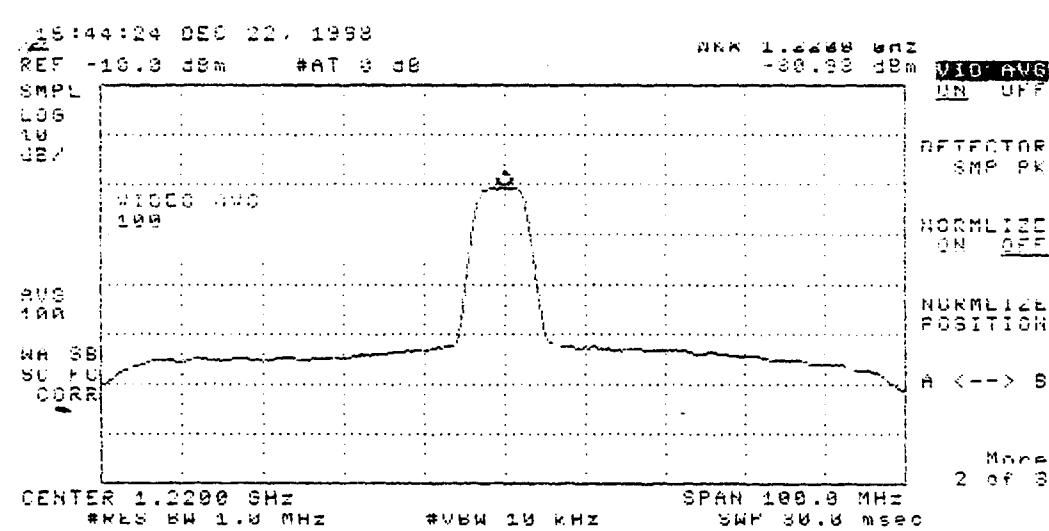
### Fig. IV-1: Sample Signal Power Spectrum -- Site 1

(a) NP Signal Power Spectrum – Po (Ku-Band)  
 -Test Set and Precision Horn  
 -HP8563E Spectrum Analyzer

(b) NP Signal Power Spectrum – Px (L-Band)  
 - DBS System and DBS Antenna  
 - HP8591E Spectrum Analyzer

- (a) Test Set with Precision Antenna to NP-Tx
- (b) DBS System with DBS Antenna to NP-Tx

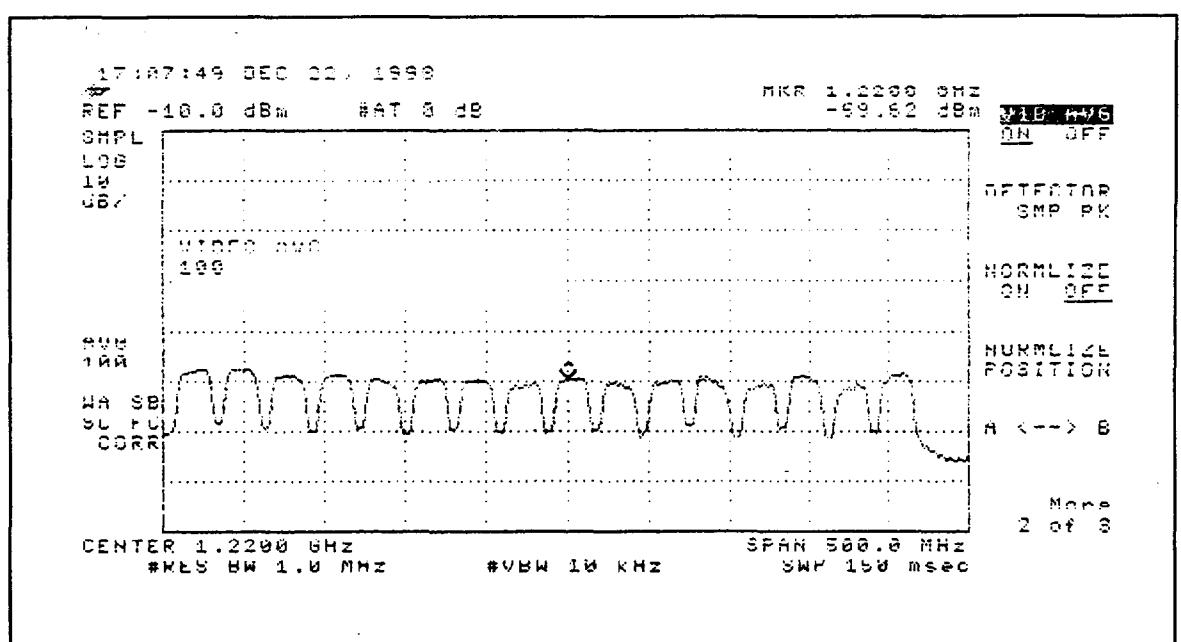
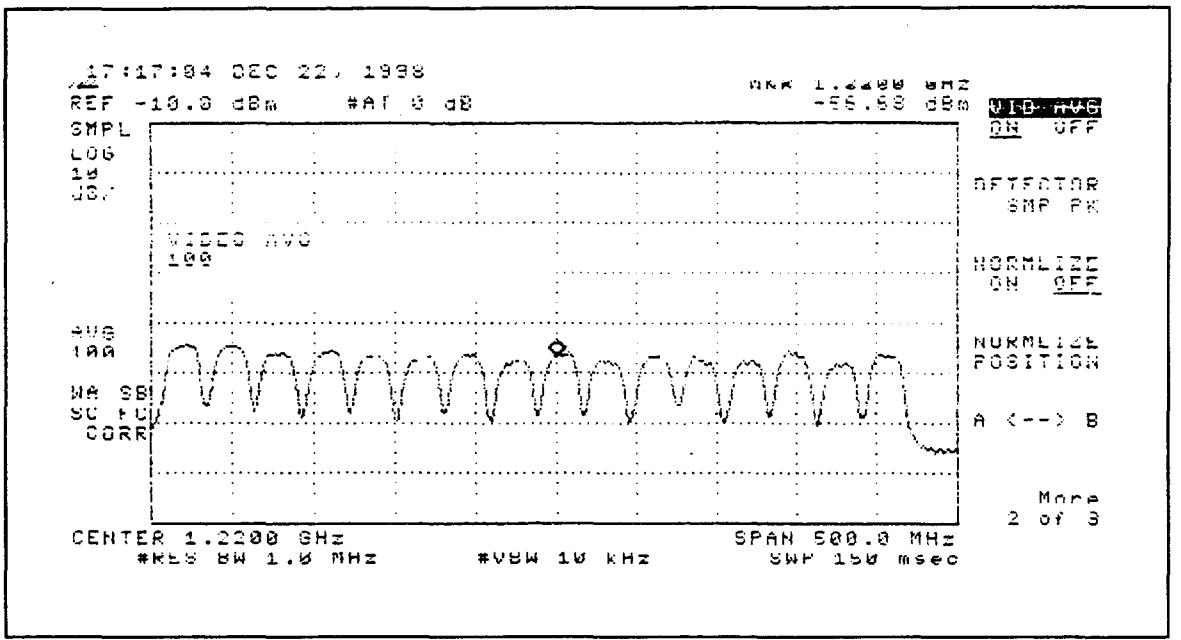
### **Fig. IV-2: Sample Signal Power Spectrum -- Site 1**

(a) Direct TV Signal – Px (L-Band)  
-HP8591E Spectrum Analyzer

(b) Echostar – Px (L-Band)  
- HP8591E Spectrum Analyzer

- (a) DBS System with DBS Antenna to DTV Satellite
- (b) DBS System with DBS Antenna to Echostar Satellite

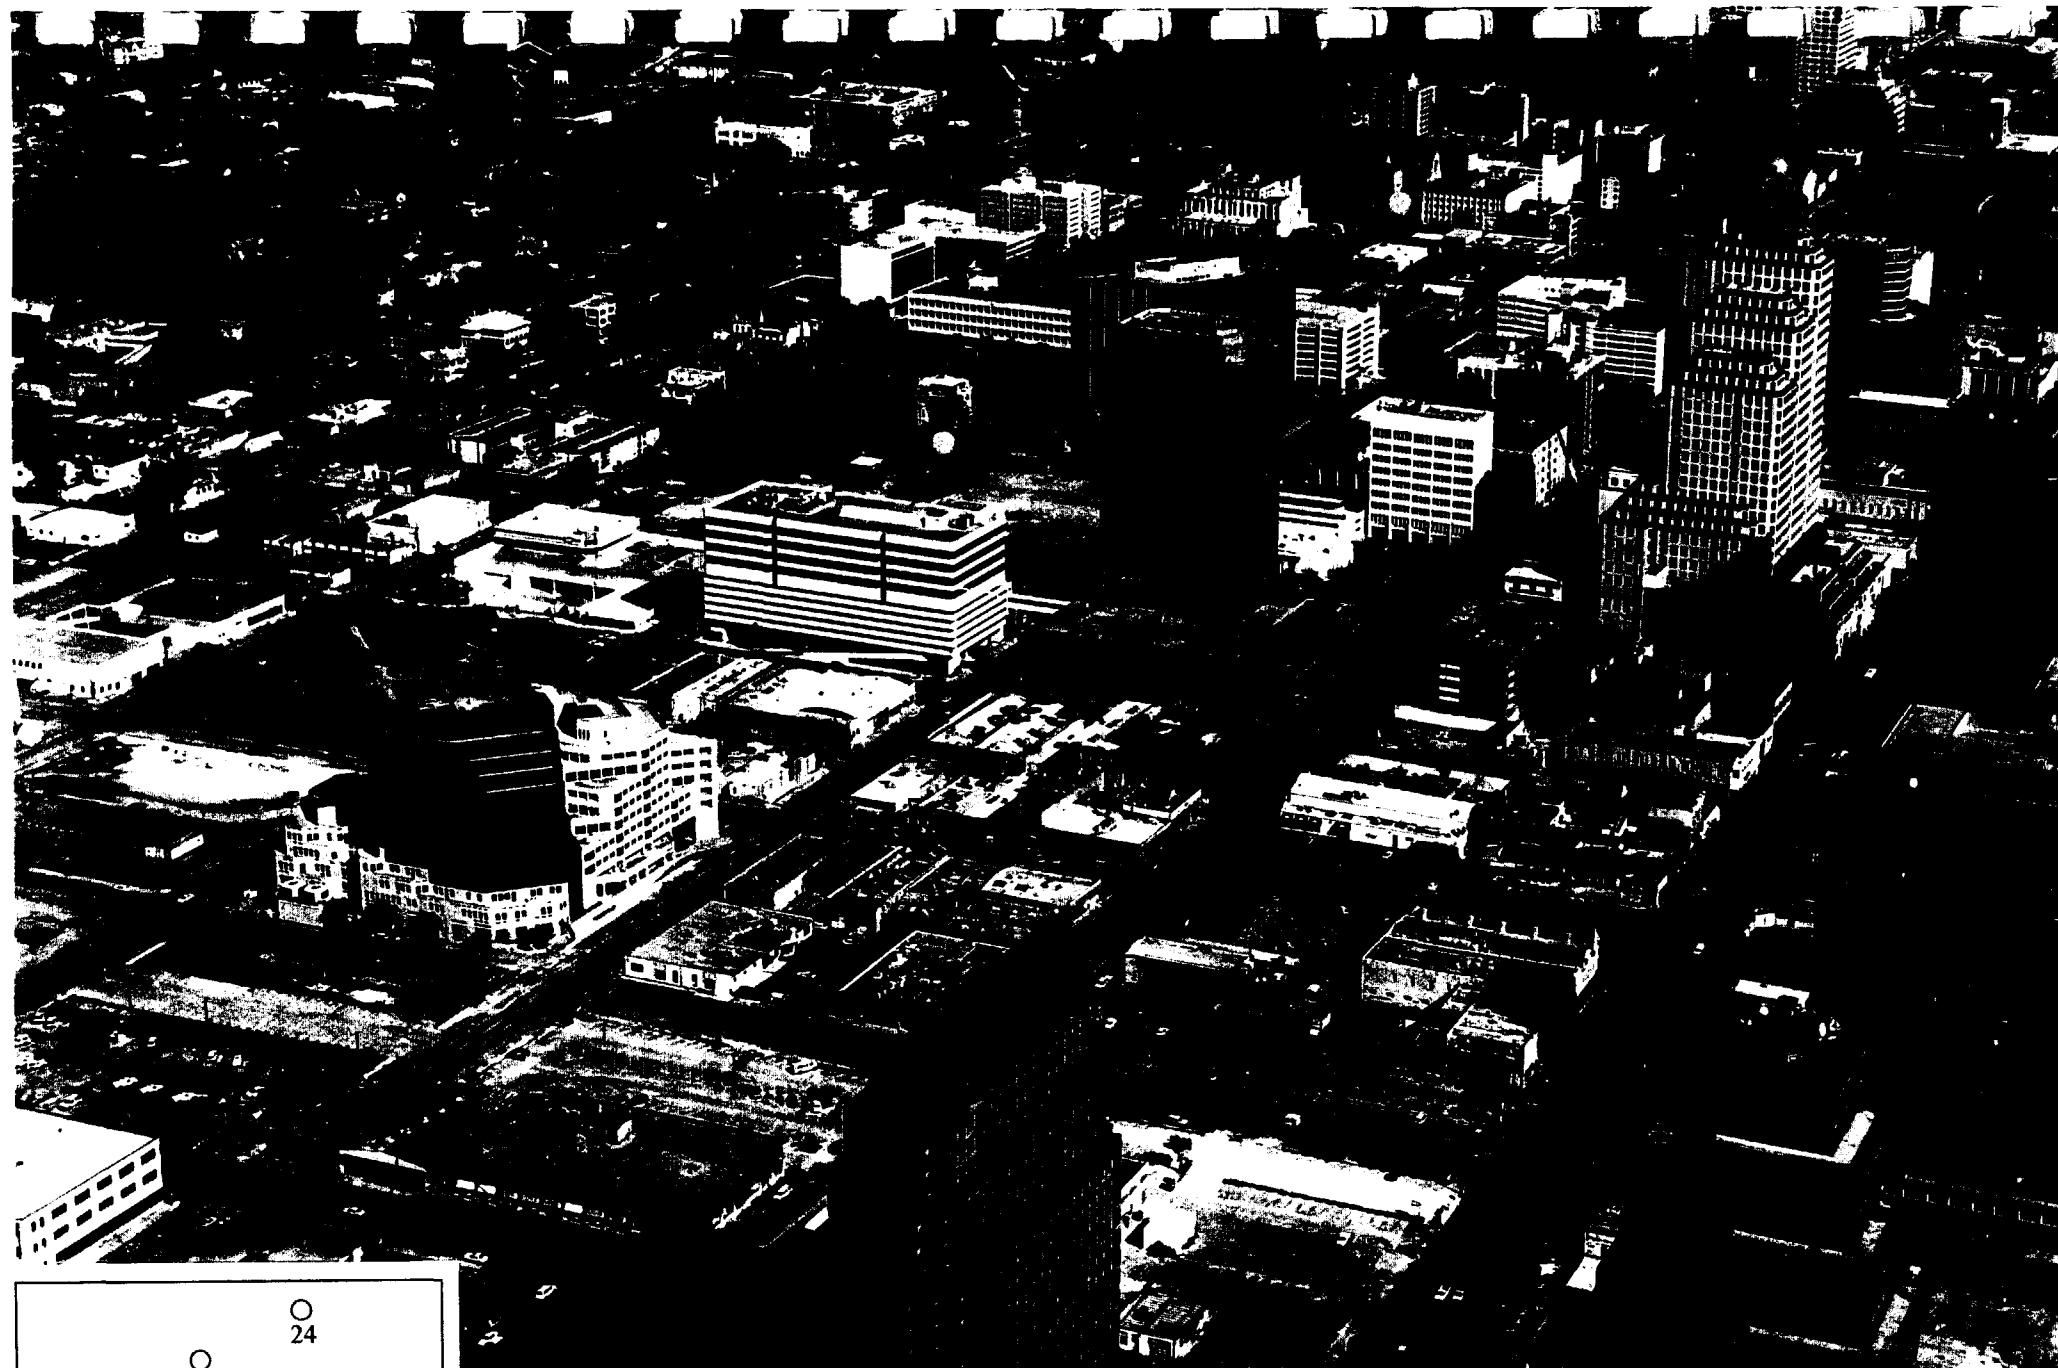
**Fig. IV-P5: Photo 5 - NP Transmitter and Sites to NW of Transmitter -- Perspective View to NW.**

Sites 22, 23, 24, and 25 were used to sample a region of downtown Austin in the area to the northwest of the NP transmitter. Site 25 is actually in a residential area to the west of the main downtown area. These sites are shown in the Figure IV-2 Site Map and are also visible in some of the aerial photo maps. The purpose for these sites was to examine the NP transmitter signal strength in the area 'behind' the transmitter, where the signal is expected to be lower due to the directional pattern of the transmit antenna. A further objective was to investigate the issues of NP signal reception, multi-pathing and DBS interference in this environment.

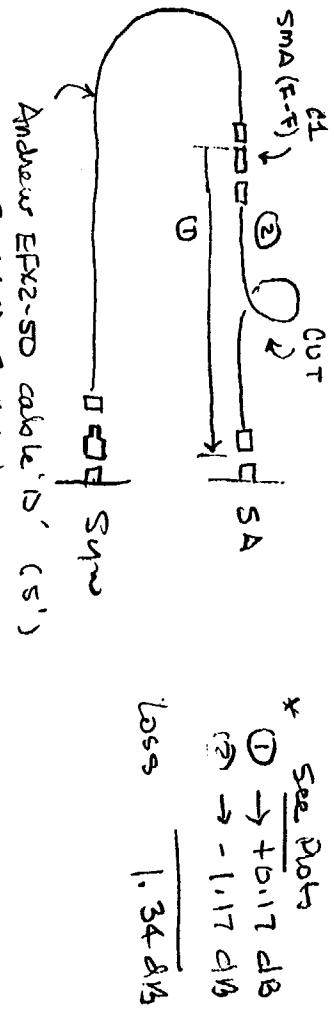
Cal cable - Home to LNA - HP11500E - Ref DSW-HP1

Anderson EFX2-50 cable 'D' (5')  
SMA(F) - SMA(M)

- After reading scattering over 0.5 dB - values based on avg.  
of several trip.
- Assume C1 [SMA(F-F) adapt] loss ~ 0.3 dB
- ⇒ assign to DSW-HP1 ⇒ -1.0 dB (insertion loss)
